Docket No. 217 – Development and Management Plan Inspection

Date: July 12, 2006

Inspector: Diana Walden

Location: 345kV Underground Route

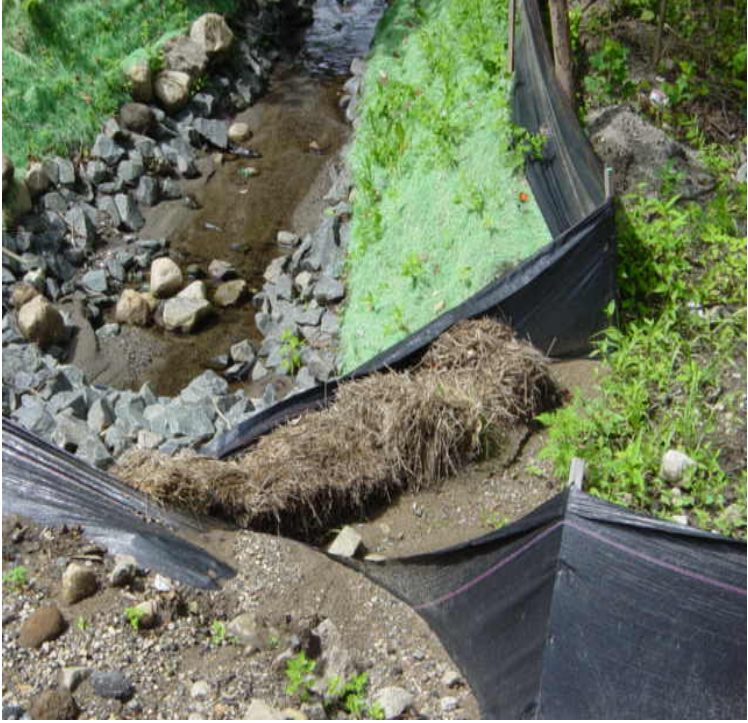
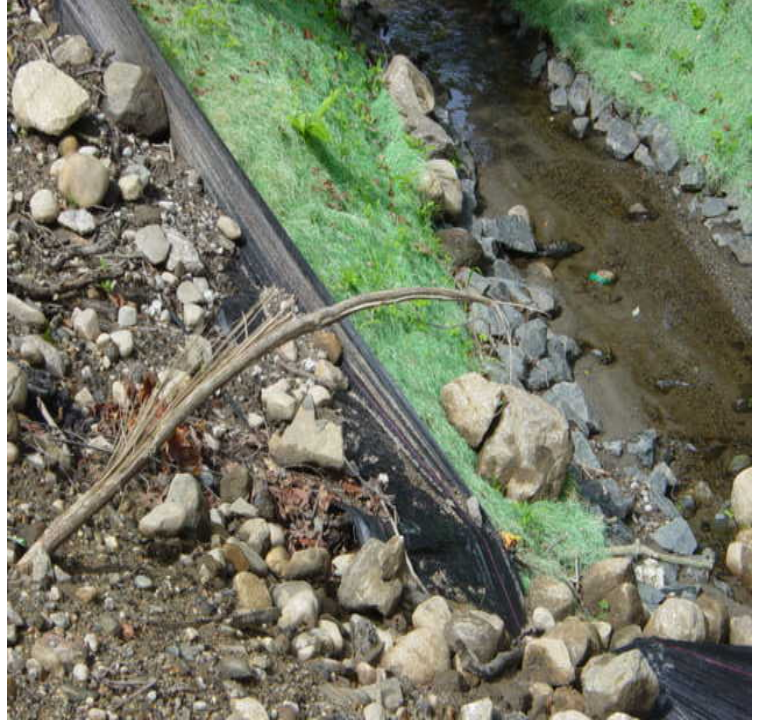
- Sediment and stone continue to overwhelm the silt fence near the swale on Old Danbury Rd. Several small stockpiles are also located here 6/29-7/12/06	-Pull back the sediment and restore the silt fence. The EC mats are in good shape. 6/29-7/12/06 Also consider removing accumulated sediment in the swale. 7/12/06	-Needs attention

345kV (Old Danbury Rd) Both photos show areas where the last few rain events had washed sediment and stone over the silt fence. The fence needs to be repaired and possibly reinforced with haybales. 7/12/06

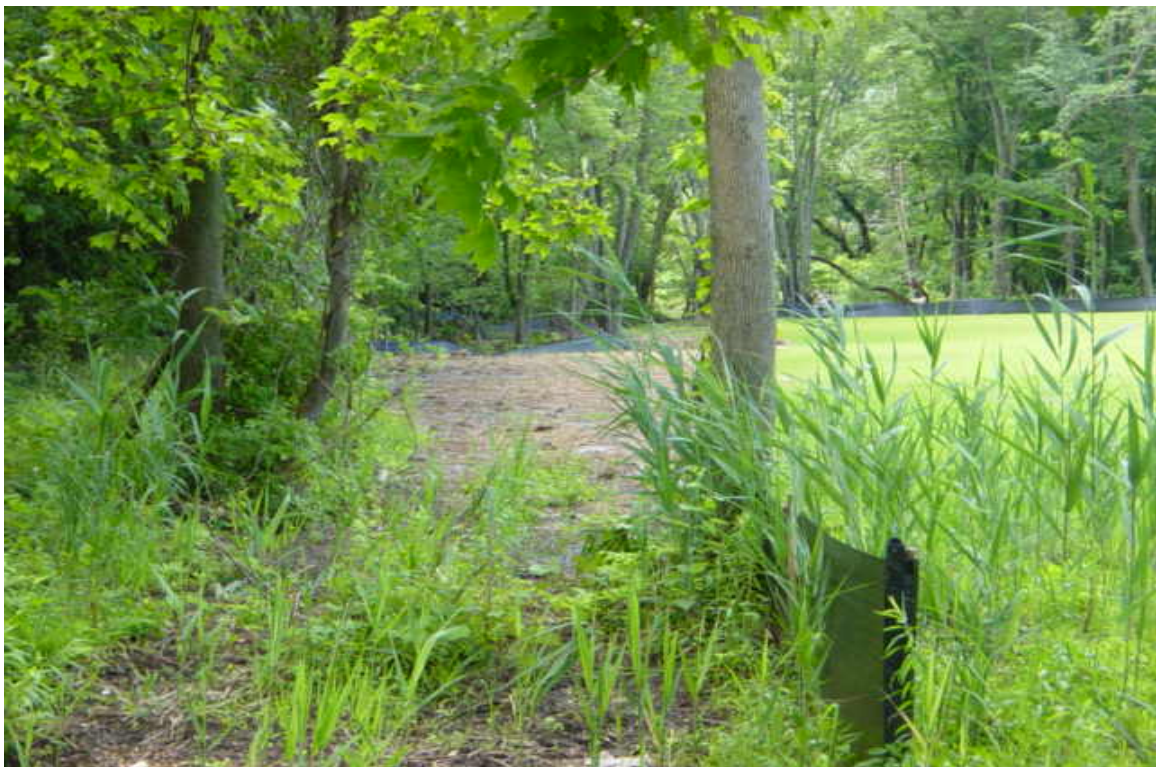
leaks) if they will be used or stored on site. - Check equipment status on a regular basis and keep spill kits on hand. - Report spills immediately, even if they are being controlled.	
Additional Observations	- The invasive species Phragmites was noted growing back at the School Rd HDD site. This had been present prior to work here and will be difficult to prevent. 7/12/06	-Continue to monitor and attempt to keep establishment from occurring in new areas.

(School Rd HDD) Photo shows a view of the site along the eastern side where the wetland area had been restored. The invasive species *Phragmites* had been present prior to the work and site disturbance and will likely continue to re-establish here. 7/12/06

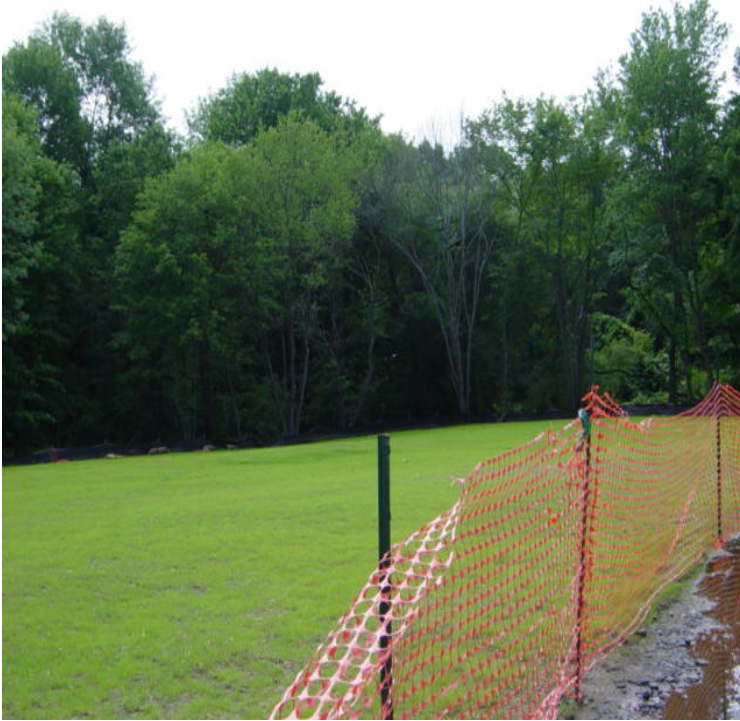
Photo on the left shows the grass growth continuing within the restored HDD site. (Wilton HS): Photo on the right shows the old jack and bore site near Wilton HS. Efforts to re-vegetate the area were more successful this time. 7/12/06

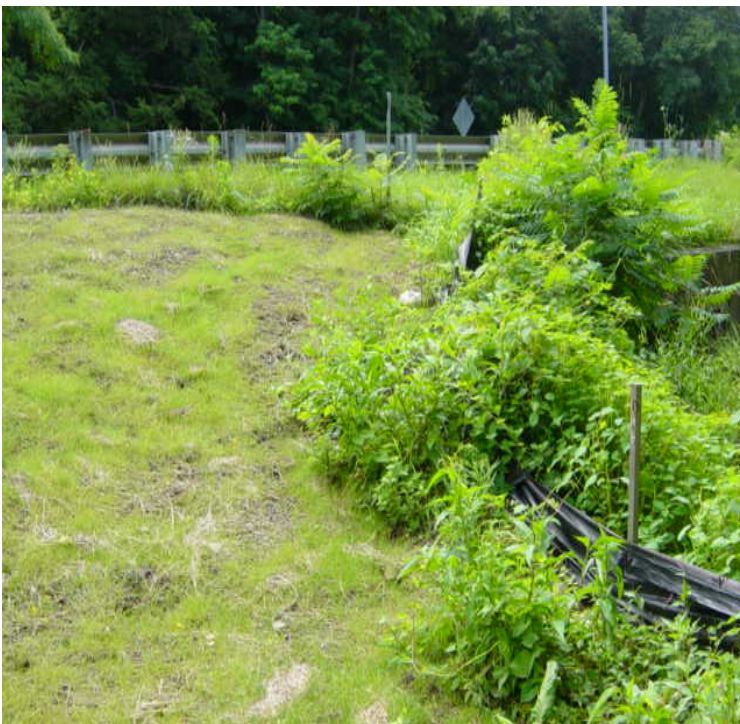
Photo on the left shows the northern side of the stream, moving towards Allens Meadow Park. Grass growth is also increasing in this restored area. (Georgetown Deli): Photo on the right shows the bank in good shape where the boulders had been installed for reinforcement. 7/12/06

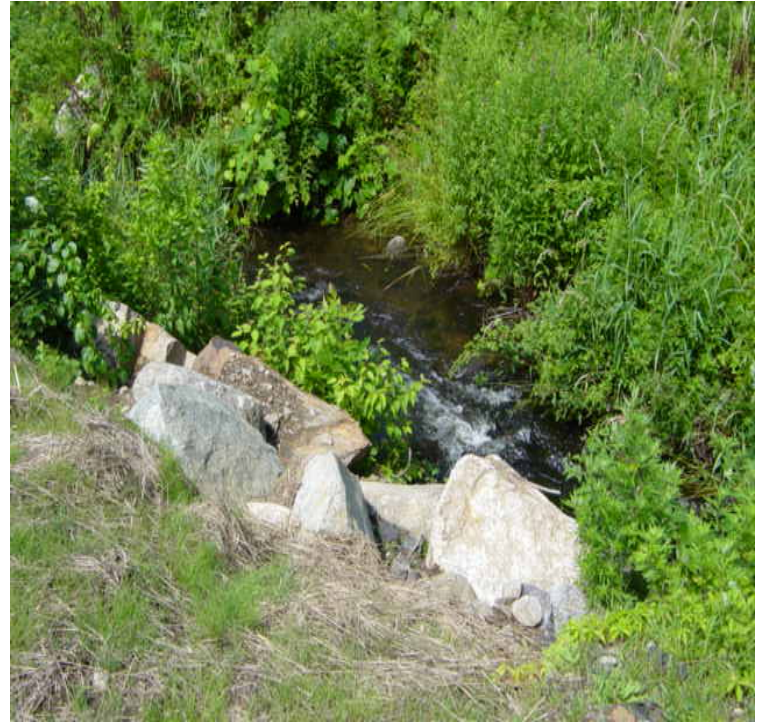
Rt. 107	- At the Georgetown Deli J&B, vegetative growth continues at all of the restored areas and the boulders are holding up well. 7/12/06	-Due to the sandy soils, EC mats are installed here to promote stabilization. Continue to monitor 5/31-7/12/06	- Vegetative growth continues

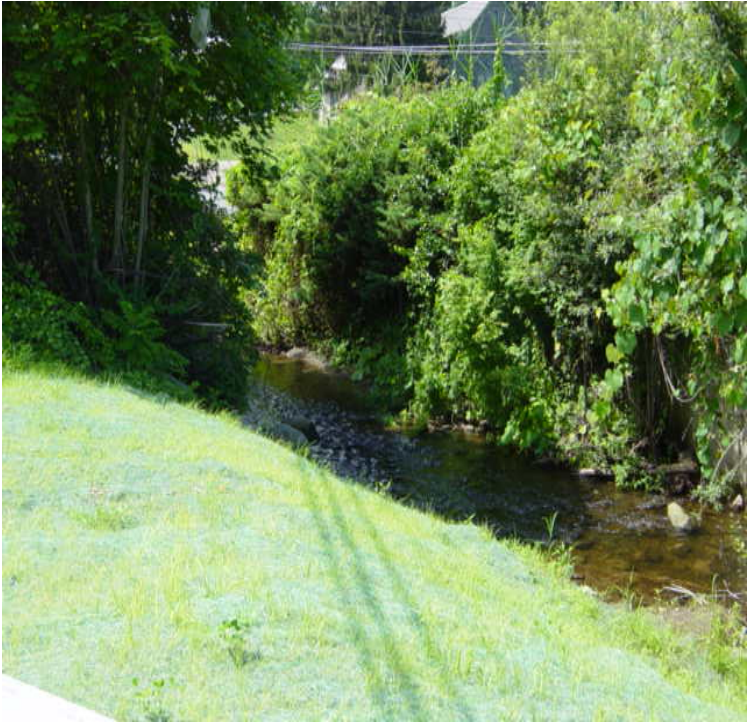
Photo on the left shows vegetative growth increasing along the restored streambank at Georgetown Deli. (New HDD) Photo on the right shows a view of the operations and the bore pit. 7/12/06

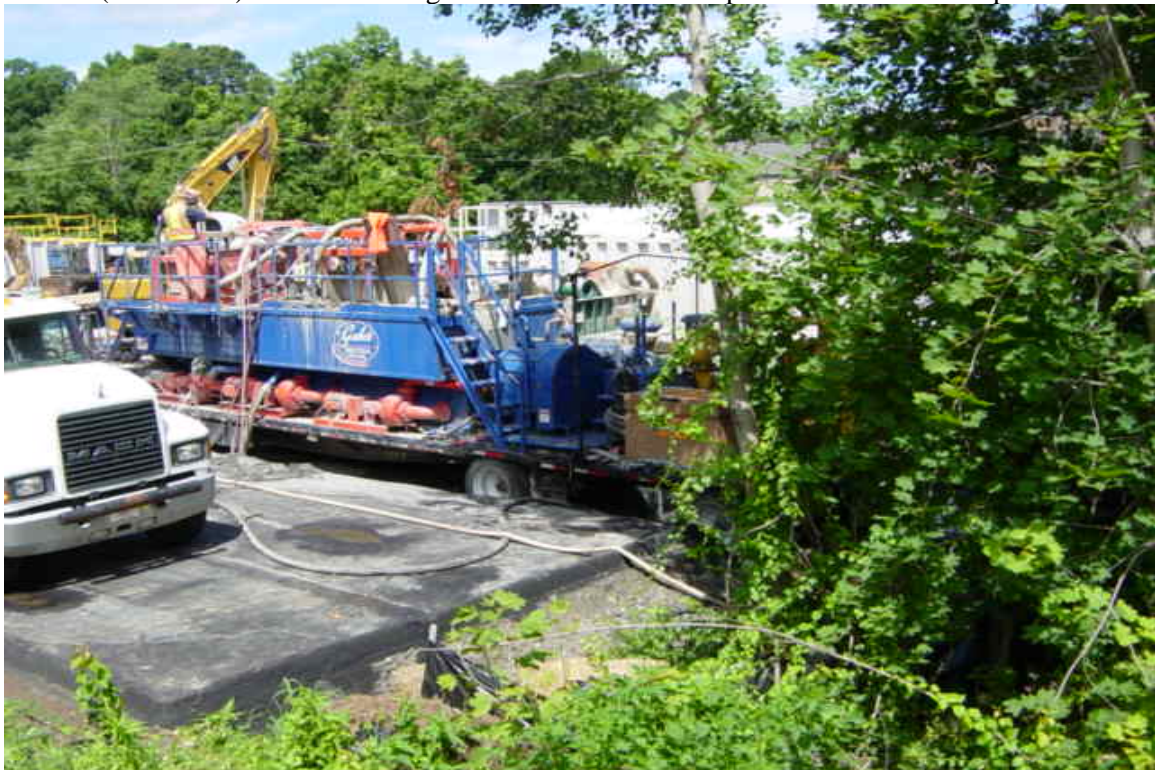
Photo shows another view of the operations and equipment at the new HDD site. 7/12/06
